Report No. : TAK-2018-065174

Salt Spray(Fog) Test

1.1 Rep. No	: TAK-2018-065174
1.2 Customer	: BL Tech Co., Ltd.
1.3 Specimen	: PRAX Repair Tape
1.4 Quantity	: 2 EA
1.5 Test Method	: ASTM B117-16
1.6 Test Period	: Mar. 24, 2016 ~ Mar. 04(240 h)

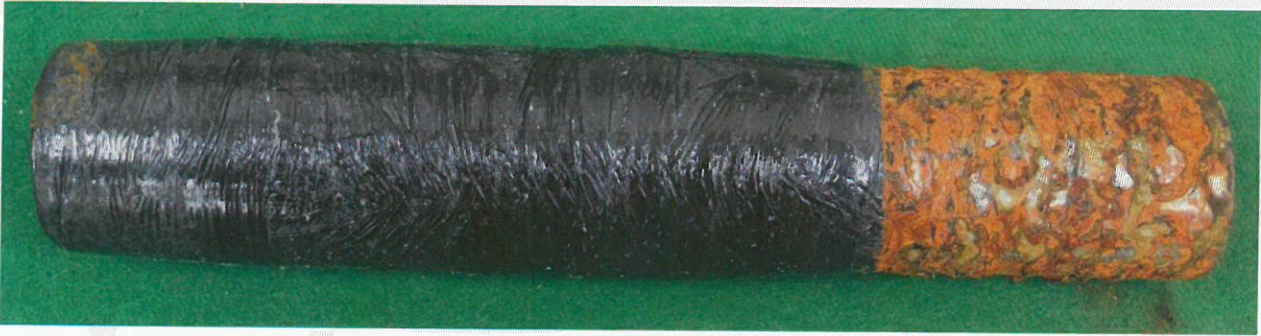
PRAX Repair Tape(1)

▶ Corrosion products of ferrous(Red rust) were observed on untapped metal surfaces and no corrosion products of ferrous(Red rust) were observed on the tape surface.

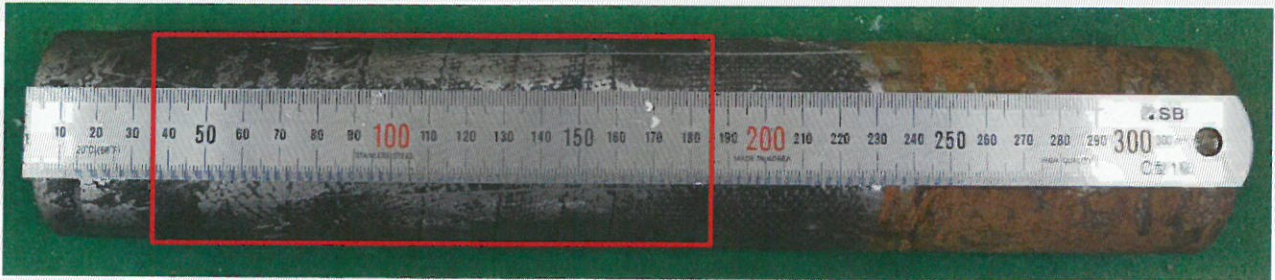
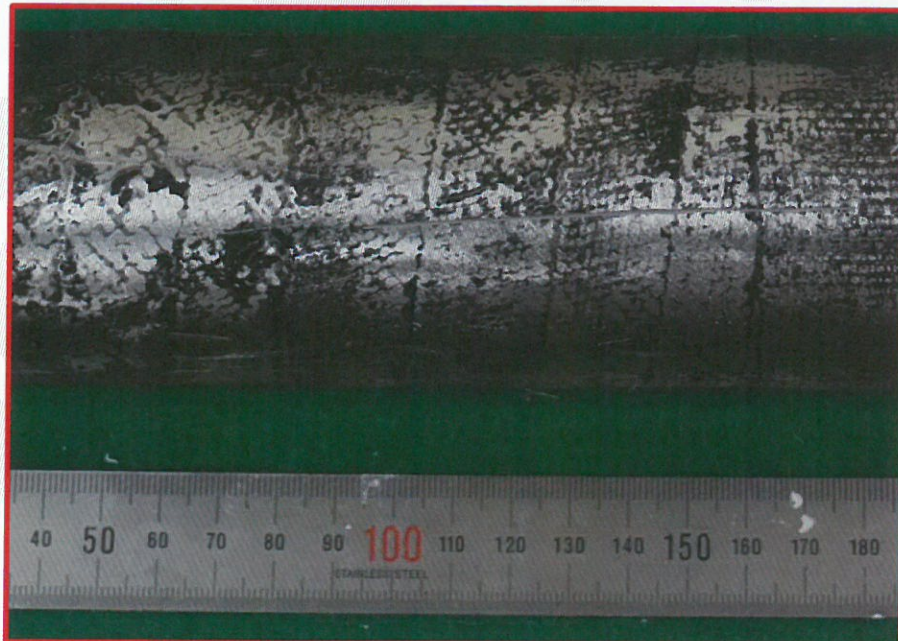
5.4.1 PRAX Repair Tape(1)

▶ The metal surface was observed after removing the tape(PRAX Repair Tape) and there was no visible corrosion products of ferrous(Red rust)

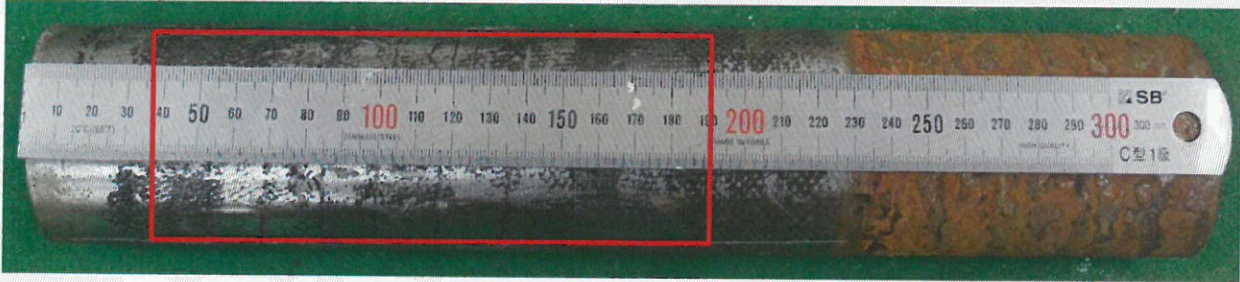
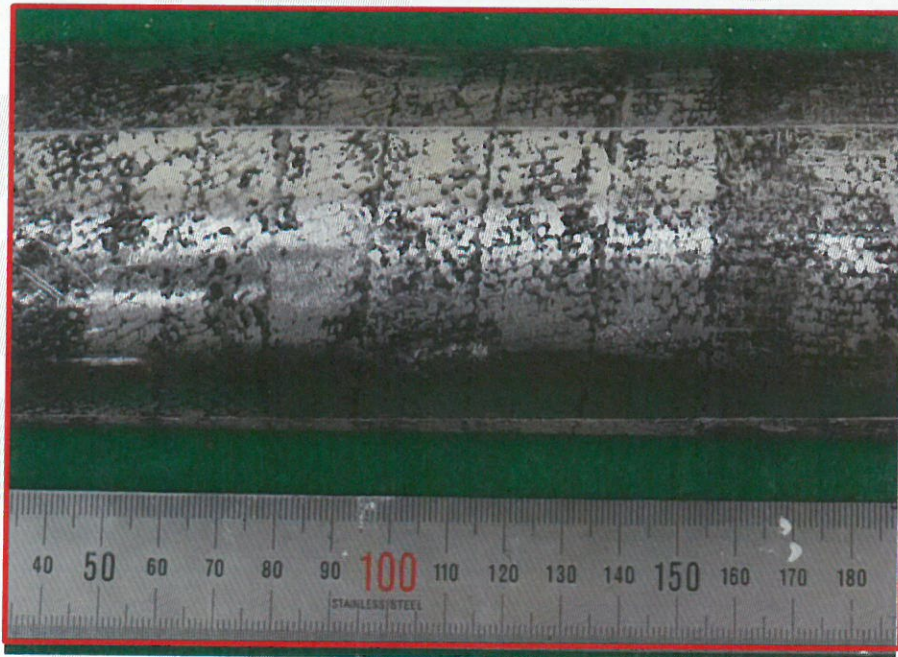
5.4.2 PRAX Repair Tape(2)

▶ The metal surface was observed after removing the tape(PRAX Repair Tape) and there was no visible corrosion products of ferrous(Red rust)
